**Hazardous Materials Survey Report  
Reserve Bank of Australia (RBA)**

**Carabella Street, Kirribilli NSW**

# Hazardous Materials Survey Report

## Reserve Bank of Australia (RBA)

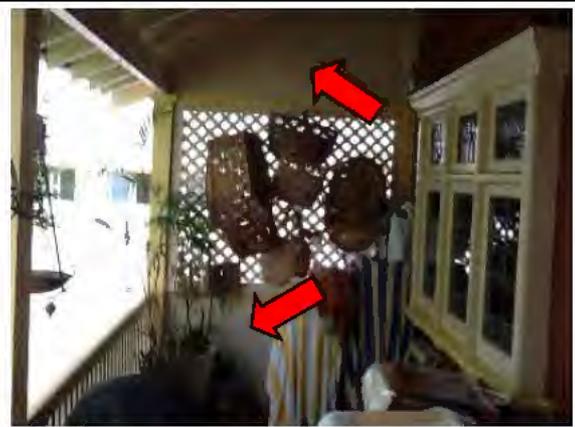
**Photo 41.** Level 2 (Flat no.1), Exterior, Northwest Balcony, North wall infill panels - Asbestos-containing fibre cement

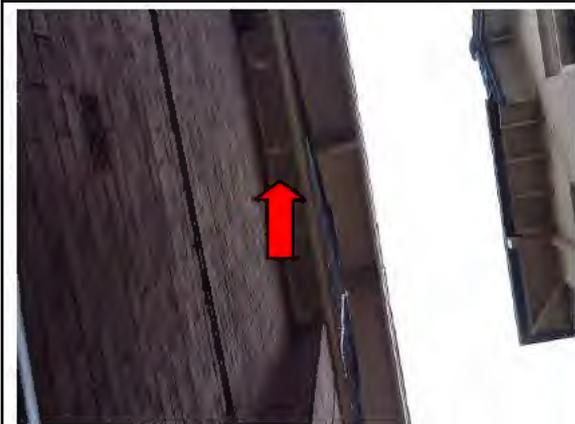
**Photo 42.** Level 2, Exterior, Roof, East, Eaves - Presumed compressed cement sheeting

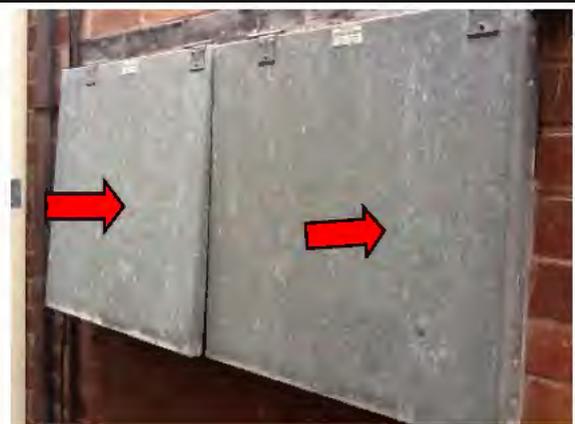
**Photo 43.** Level 1, Exterior, North wall, Switchboards - Presumed electrical backing boards

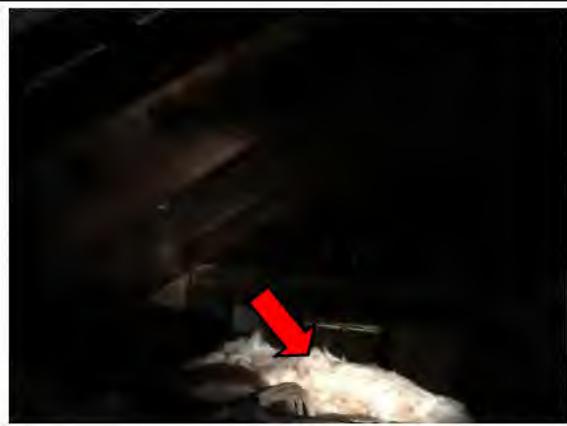
Location Item Description	Photo No.	Form	Extent	Condition	Control Recommendation
<b>10 Carabella Street</b>					
Roof Space/Cavity Roof Insulation SMF insulation batts	44	Un-Bonded	50 m <sup>2</sup>	Poor / Low	Remove under controlled conditions prior to demolition/refurbishments.
Roof Space/Cavity Hot Water Storage Tanks Suspected SMF internal insulation	-	Bonded	2 units	Good / Low	Maintain <i>in-situ</i> in current condition. Remove under controlled conditions prior to demolition/refurbishments.

**Photo 44.** Roof space, Interior, Roof insulation, Insulation batts – Mineral wool SMF

- Where SMF pipework insulation was identified in a poor condition the damaged material should be removed and the remaining insulation sealed by an appropriate contractor;
- SMF material should be maintained in a good condition; &
- Confirmed SMF materials should be removed under controlled conditions prior to any refurbishment works.

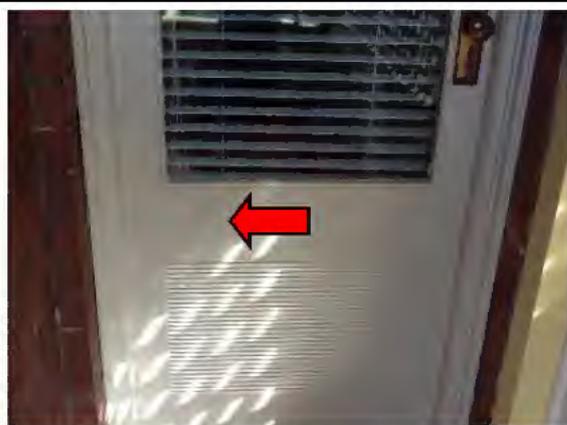
**Photo 45.** Level 1 & 2, Exterior, Door & frames – Lead-containing cream upper & white lower coloured paint systems

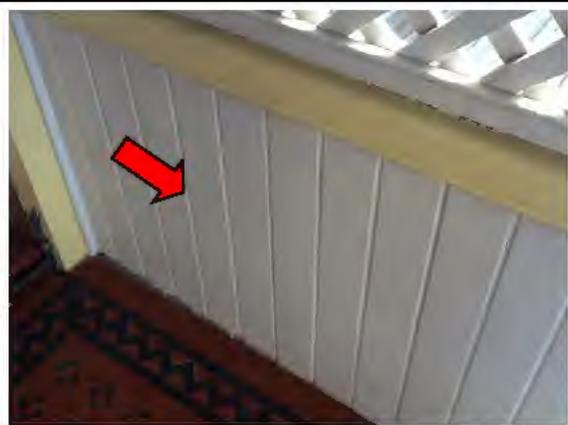
**Photo 46.** Levels 1 & 2, Exterior, Timber work – Lead-containing cream upper & white lower coloured paint systems

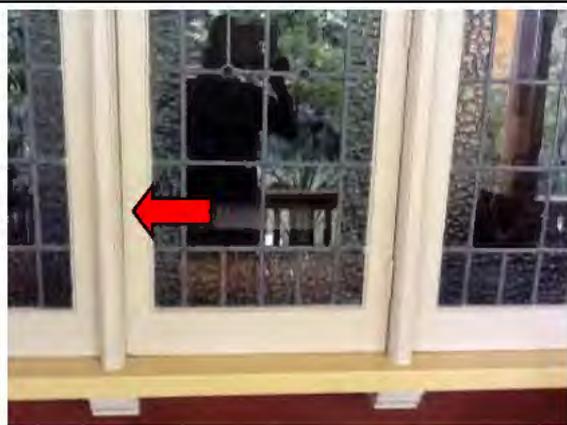
**Photo 47.** Levels 1 & 2, Exterior, Window frames – Lead-containing cream & yellow upper & white lower coloured paint systems

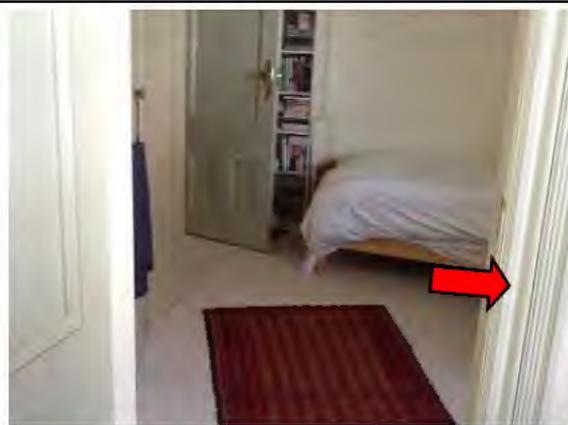
**Photo 48.** Levels 1 & 2, Interior, Door & window frames – Lead-containing white lower coloured paint system

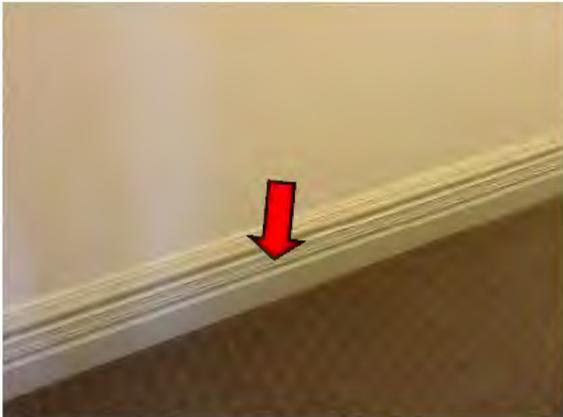
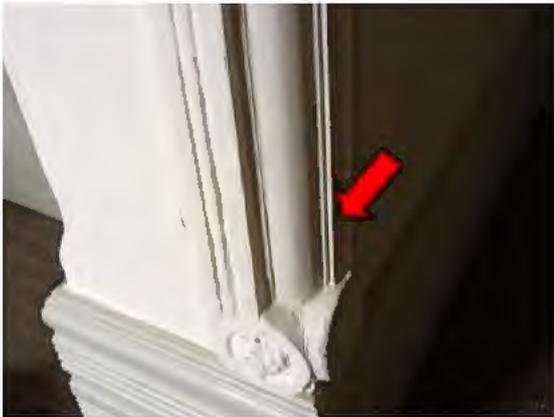
Interior, Levels 1 & 2 Skirting Board White lower coloured paint systems	49	Assumed Positive	-	~ 20 m <sup>2</sup>	Good	Maintain in current condition. Confirm lead percentage content prior to refurbishment. Dust generation is recommended to be minimised during any refurbishment works
Interior, Levels 1 & 2 Walls, Décor Trim White lower coloured paint systems	50	Positive	-	~ 20 m <sup>2</sup>	Good	Maintain in current condition. Confirm lead percentage content prior to refurbishment. Dust generation is recommended to be minimised during any refurbishment works
Interior, Levels 1 & 2 Ceiling, Covering & Décor Trim White lower coloured paint systems	51	Assumed Positive	-	~ 50 m <sup>2</sup>	Good	Maintain in current condition. Confirm lead percentage content prior to refurbishment. Dust generation is recommended to be minimised during any refurbishment works
Exterior, Levels 1 Timber Work White lower coloured paint system	52	Assumed Positive	-	~ 50 m <sup>2</sup>	Good	Maintain in current condition. Confirm lead percentage content prior to refurbishment. Dust generation is recommended to be minimised during any refurbishment works

<p><b>Photo 49.</b> Levels 1 &amp; 2, Interior, Skirting board/trim – Assumed lead-containing white lower coloured paint system</p>	<p><b>Photo 50.</b> Levels 1 &amp; 2, Interior, Walls, Décor trim – Lead-containing white lower coloured paint system</p>

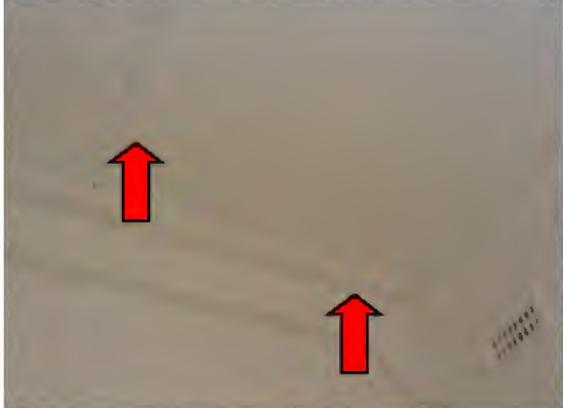
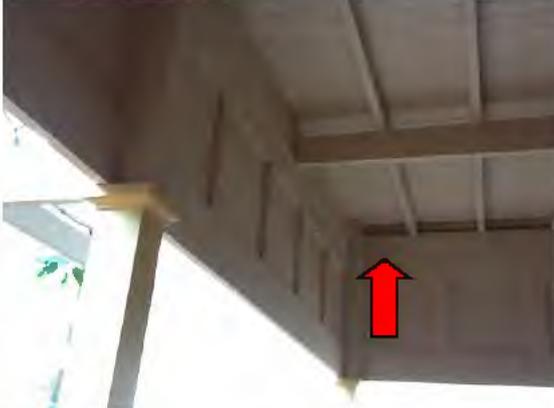
<p><b>Photo 51.</b> Levels 1 &amp; 2, Interior, Ceiling, Coving and Décor trim – Assumed lead-containing white lower coloured paint system</p>	<p><b>Photo 52.</b> Level 1, Exterior, Timber work – Assumed lead-containing white lower coloured paint system</p>

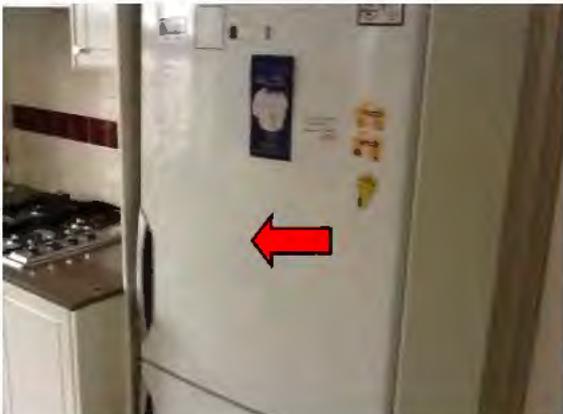
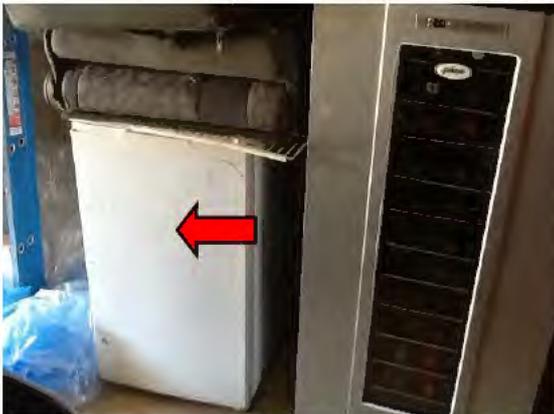
Location Colour Description, Comments	Photo No.	ODS	Extent	Condition	Control Recommendation
<b>10 Carabella Street</b>					
Levels 1 & 2, Kitchens Refrigerator unit	53	Unknown refrigerant – Presumed positive	2 unit	Good	Maintain in a good condition until removal by an adequately licenced contractor using the correct handling and disposal of refrigerants
Level 0, Garage, Stored Item Refrigerator unit	54	Unknown refrigerant – Presumed positive	1 unit	Good	Maintain in a good condition until removal by an adequately licenced contractor using the correct handling and disposal of refrigerants

<p><b>Photo 53.</b> Levels 1 &amp; 2, Interior, Kitchens Refrigerator unit – Presumed positive for ODSs</p>	<p><b>Photo 54.</b> Level 0, Interior, Garage, Store Items, Refrigerator unit – Presumed positive for ODSs</p>
